Manhole Inspection Summary

Manhole # S25OO1008MH

Location Address: **300 GOODWOOD GARDEN**

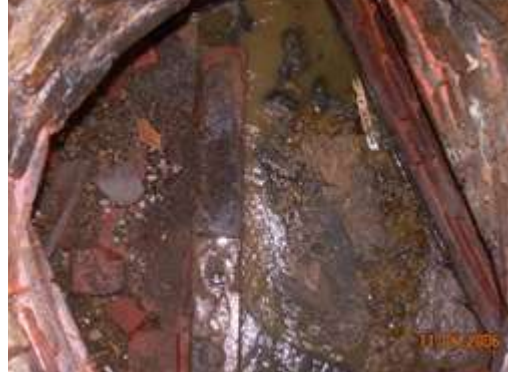
Top View

Corbel infiltration. Bench and Channel debris.

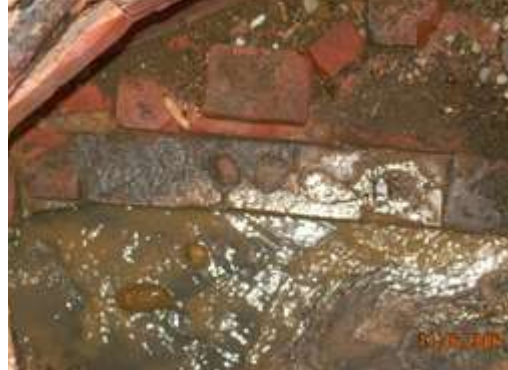
Defect

Bench and Channel debris.

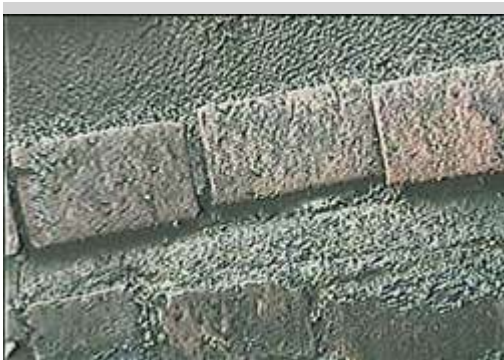
Defect

Frame leaks. Adjustment infiltration.

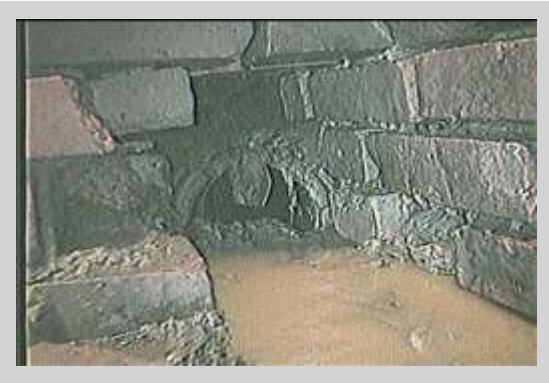
8 in. Circular Gravity Sewer Pipe Out @ 12 O'Clock

Barrel deterioration, loose brick and infiltration. Bench and Channel deterioration.

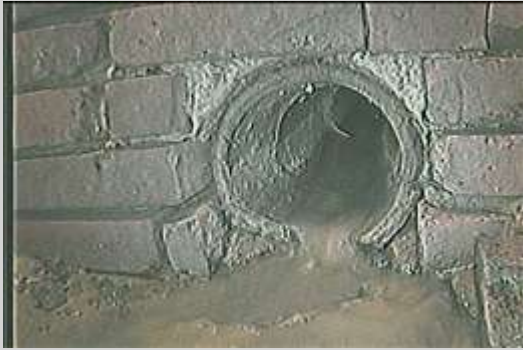
Pipe In @ 6 O'Clock

Barrel deterioration and infiltration.
